# Evaluation of Carburized and Ground Face Gears

David G. Lewicki and Robert F. Handschuh  
U.S. Army Research Laboratory, Glenn Research Center, Cleveland, Ohio

1. AGENCY USE ONLY (Leave blank)		2. REPORT DATE May 1999		3. REPORT TYPE AND DATES COVERED Technical Memorandum
4. TITLE AND SUBTITLE  Evaluation of Carburized and Ground Face Gears			5. FUNDING NUMBERS  WU-581-30-13-00 1L162211A47A

9. SPONSORING/MONITORING AGENCY NAME(S) AND ADDRESS(ES) National Aeronautics and Space Administration Washington, DC 20546-0001 and U.S. Army Research Laboratory Adelphi, Maryland 20783-1145			10. SPONSORING/MONITORING AGENCY REPORT NUMBER  NASA TM-1999-209188 ARL-TR-1998

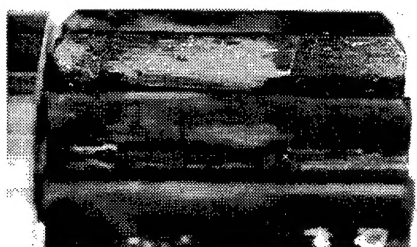
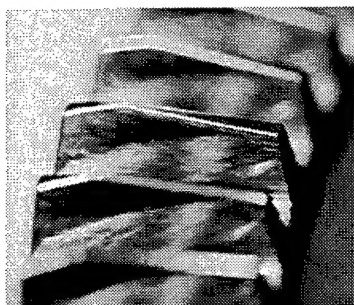
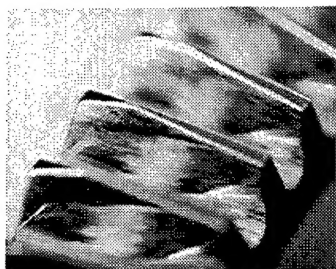
At the end of test 5 (424 N-m, 112-percent), the replacement pinions had again, a slight increase in the amount of wear compared to the pinions from test 4. This was expected due to the increased applied load. Slight wear lines were apparent near the pitch line as well as edge lines where the pinion meshed with the face-gear inner-diameter and outer-diameter regions. The marks corresponding to the face gear outer-diameter region were attributed to a few burrs on the face-gear outer-diameter edge, probably caused during hardware assembly. Slight scratching appeared at the tooth tips. Overall, however, relatively little wear was noticed. The face gears had even less noticeable wear than the pinions. As stated before, slight wear lines were noticed that appeared to correspond with the edge of the facets on the teeth. At this time, the effect of the facets on durability and performance are not known. Also, minor scratching was exhibited on the face gears near the outer-diameter tip region. Figure 13 depicts the wear after test 5. Aside from minor wear line situations, the pinions and, especially the face gears, had no significant wear problems or failure modes. (Note that the wear of the pinions in Figure 13 is just the removal of the black-oxide.) Thus, from the tests,

a) Pinion, test side.

b) Face gear, test side.

c) Pinion, slave side.

d) Face gear, slave side.

**Figure 13.** Pinion and face gear teeth after test 5 (424 N-m, 112-percent design torque).

- 1) Carburized and ground face gears demonstrated the required durability when run for ten-million cycles at loads of 64, 76, 88, 100, and 112-percent of the design torque. Other than wear lines caused by isolated situations, the spur pinions and face gears had no significant wear problems or failure modes.
